TECHNICAL NOTE

No. 1095

MARINE EXPOSURE TESTS ON STAINLESS STEEL SHEET

By Willard Mutchler

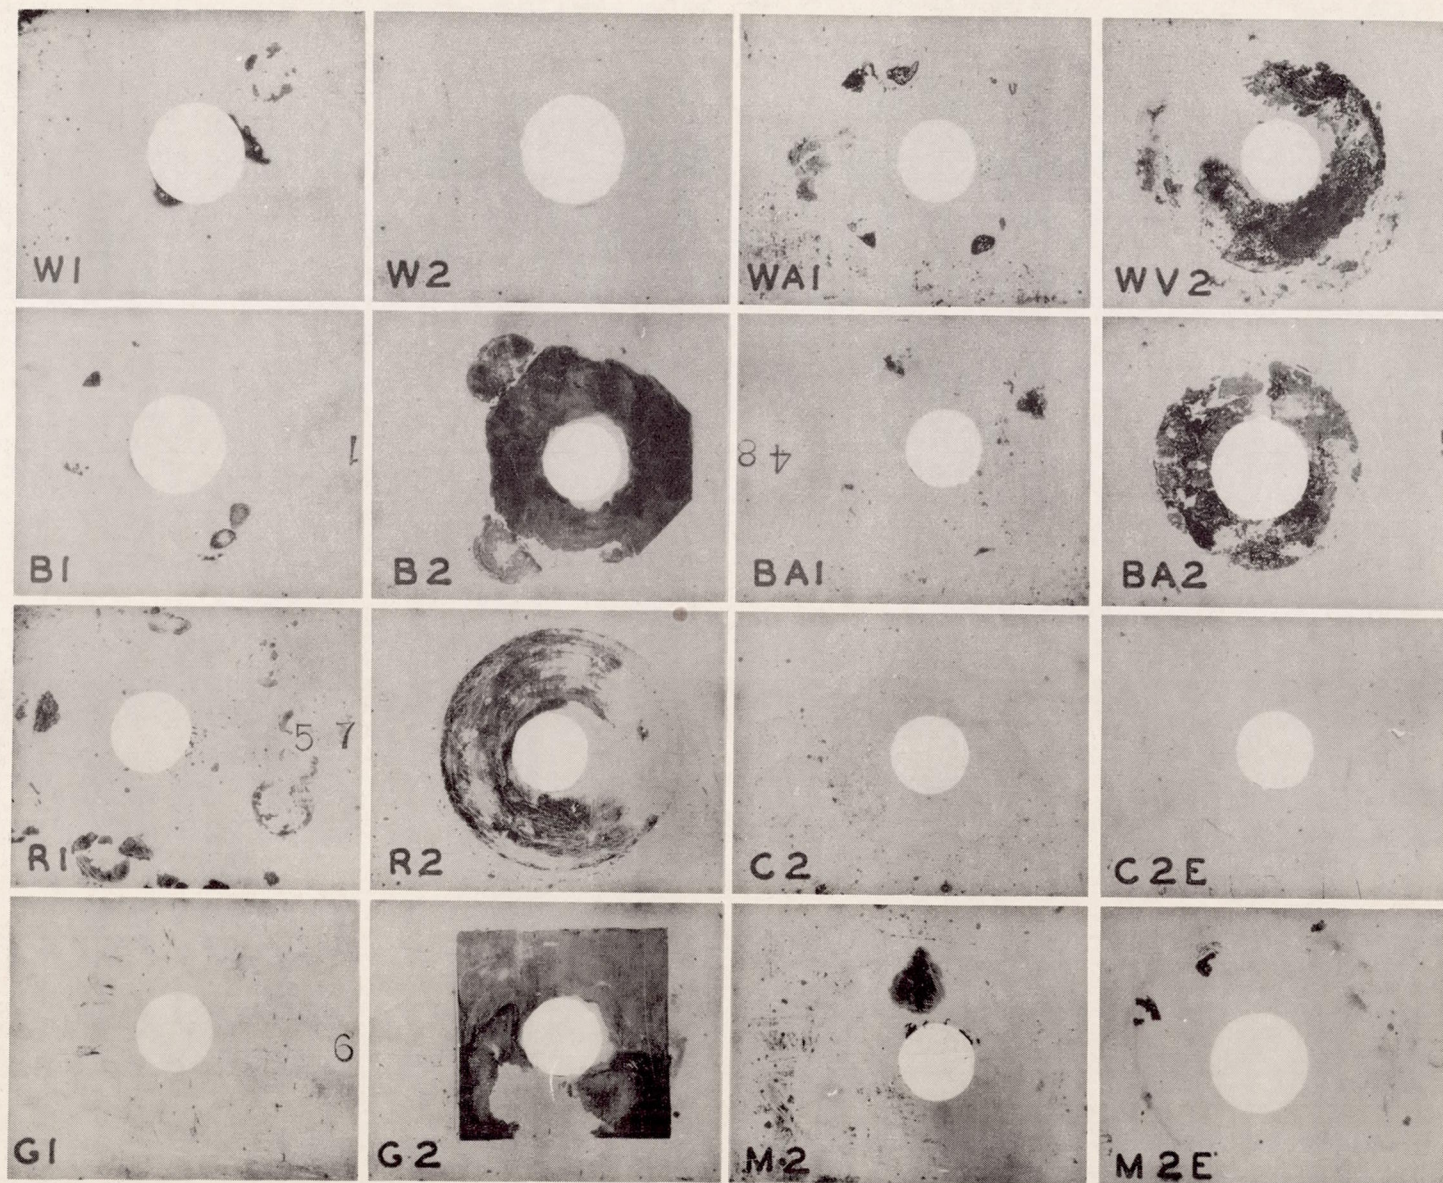
FIG. 36

Figure 36.- The four-point method of supporting panels in the tidewater racks served to prevent corrosion caused by contact with the supporting medium. The symbols:- W, wood, cypress; B, bakelite; R, hard rubber; G, glass; C, copper; M, monel metal; A separator painted with aluminum varnish; V, separator painted with clear varnish; E, mounted to permit an electric circuit; 1, four-point contacts; 2, solid contact of 1 square inch area.

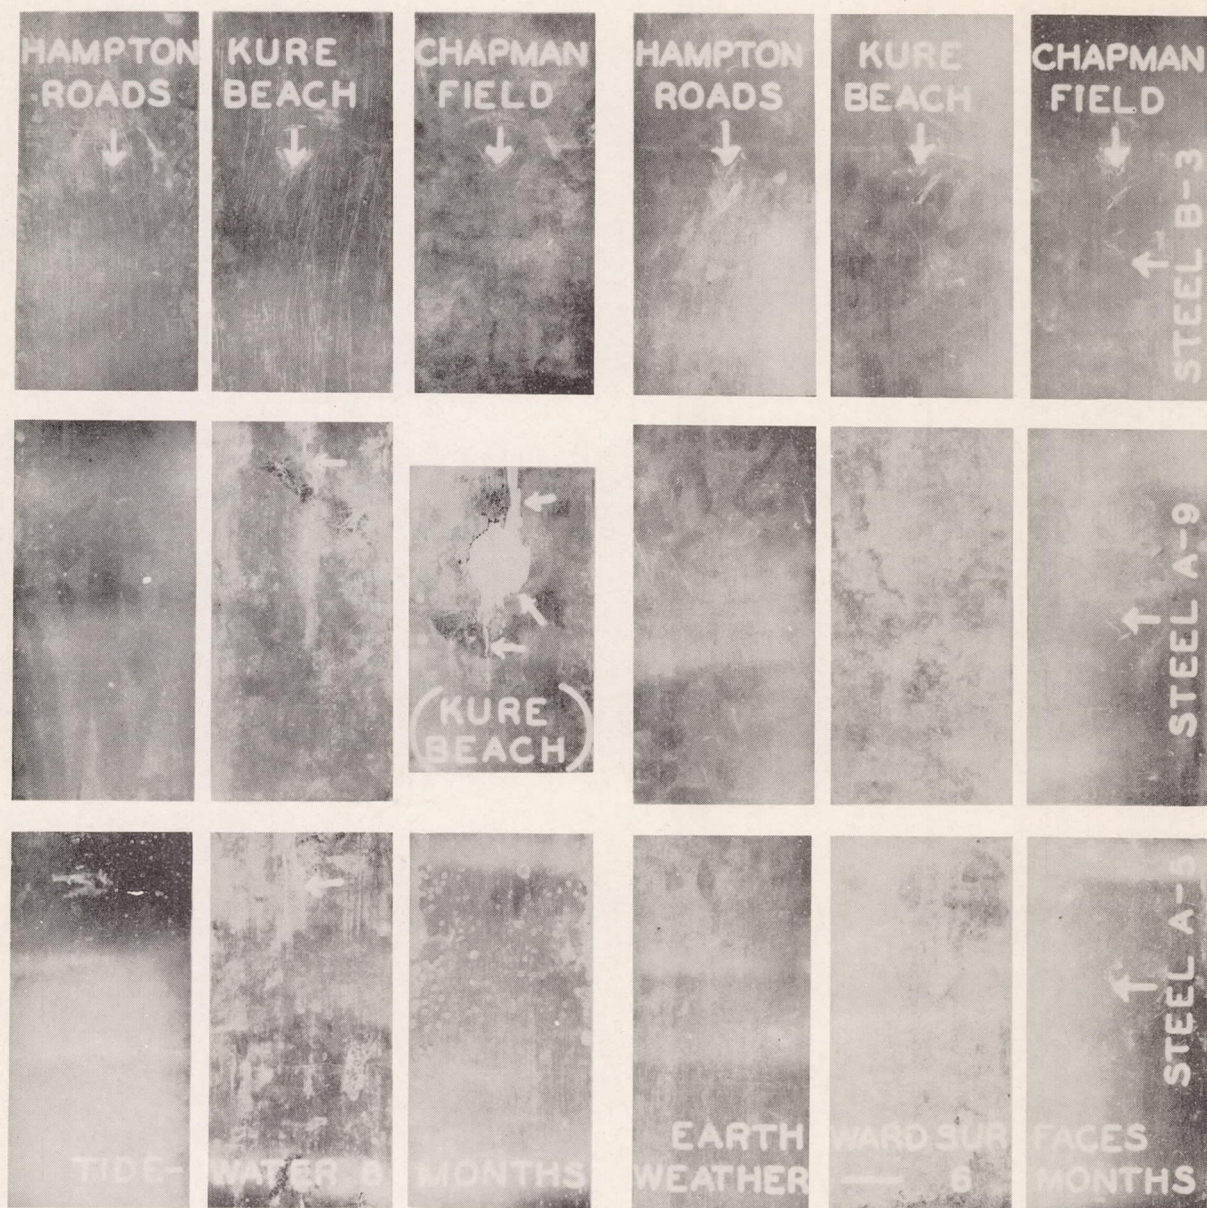
Figure 37.- Stainless steel panels exposed to the weather and tidewater as indicated. Panels exposed to sea water at Kure Beach exhibited more evidence of the action of organisms, but were rusted only where held by bakelite supports (arrows) or in streaks originating at those areas. x 1/4.

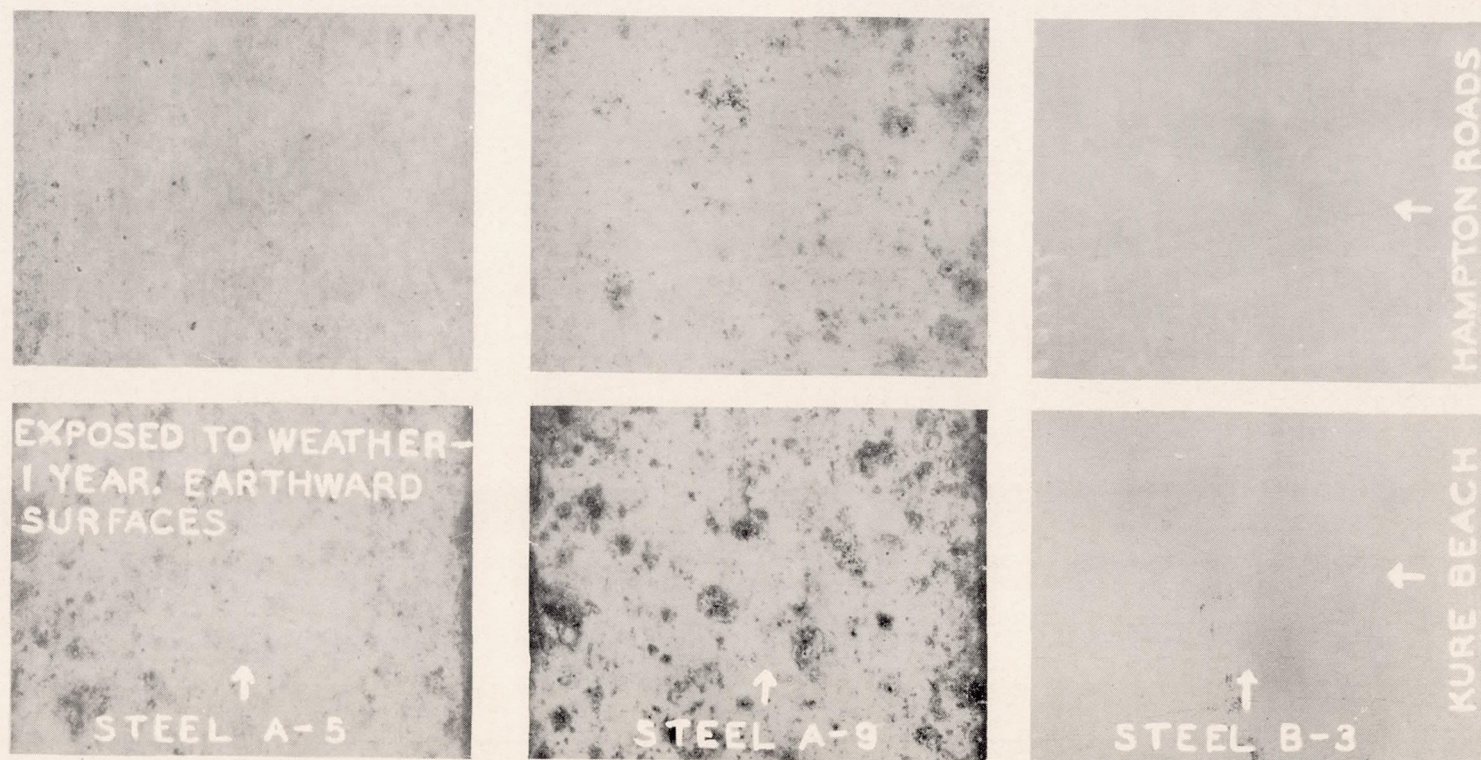
Figure 38.- Stainless steel panels, after a year's weather-exposure, were much more rusted at the Kure Beach site than at Hampton Roads. The molybdenum containing steel, however, was very much less rusted than the others. x 3/5.
